NBSIR 73-169

Fire Endurance Test of a Wood Stud Interdwelling Double Wall Construction

April 1973

Final Report

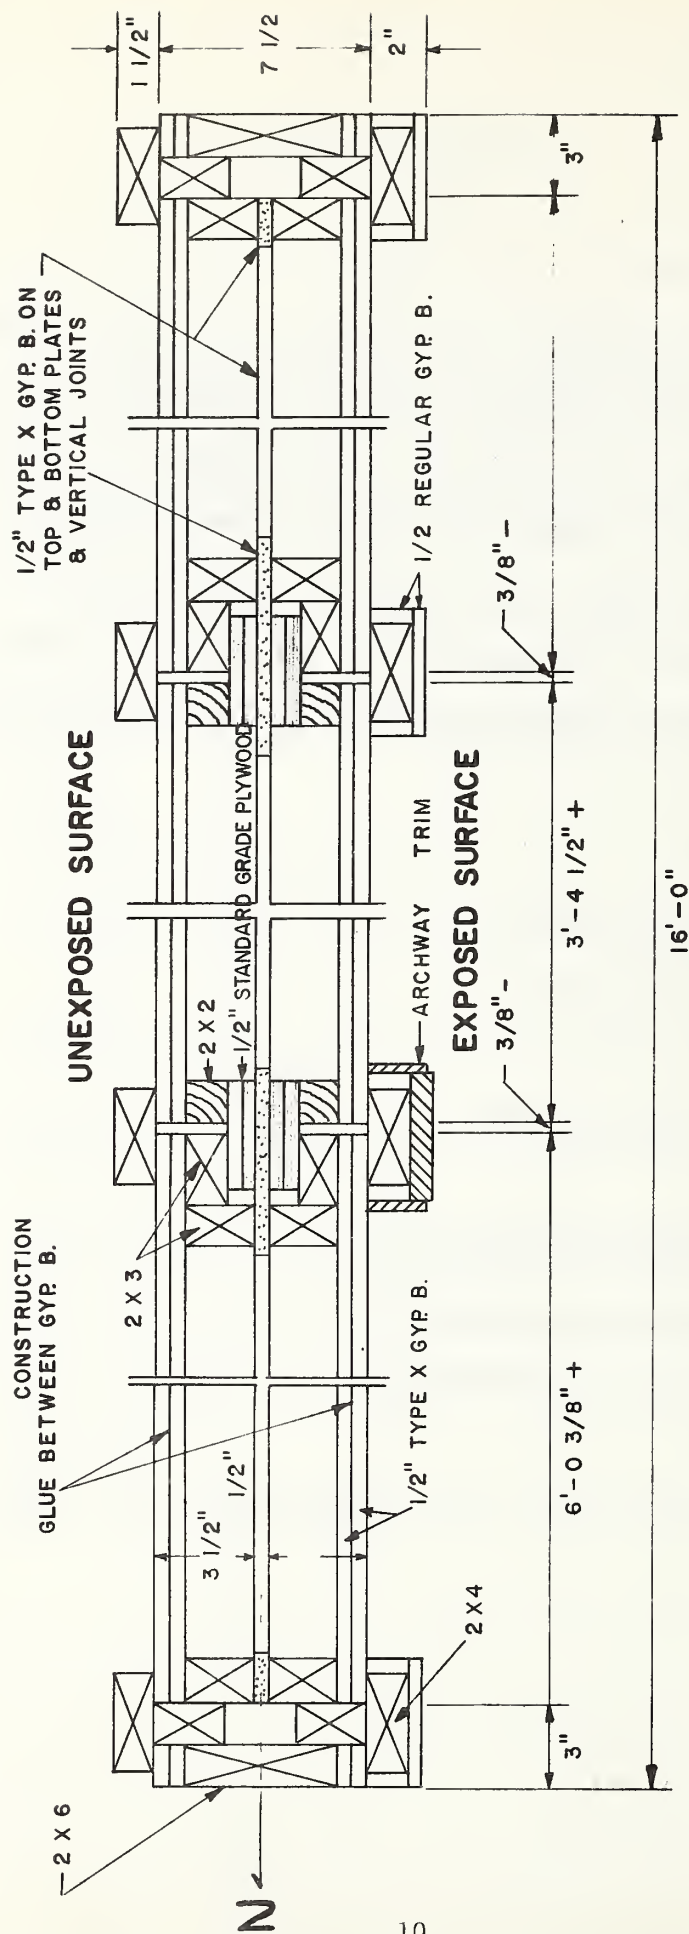
Figure 1 Construction Detail

The ends of the panel were built in accordance with actual construction procedures. The details of the joints and end construction are shown in Figure 1.

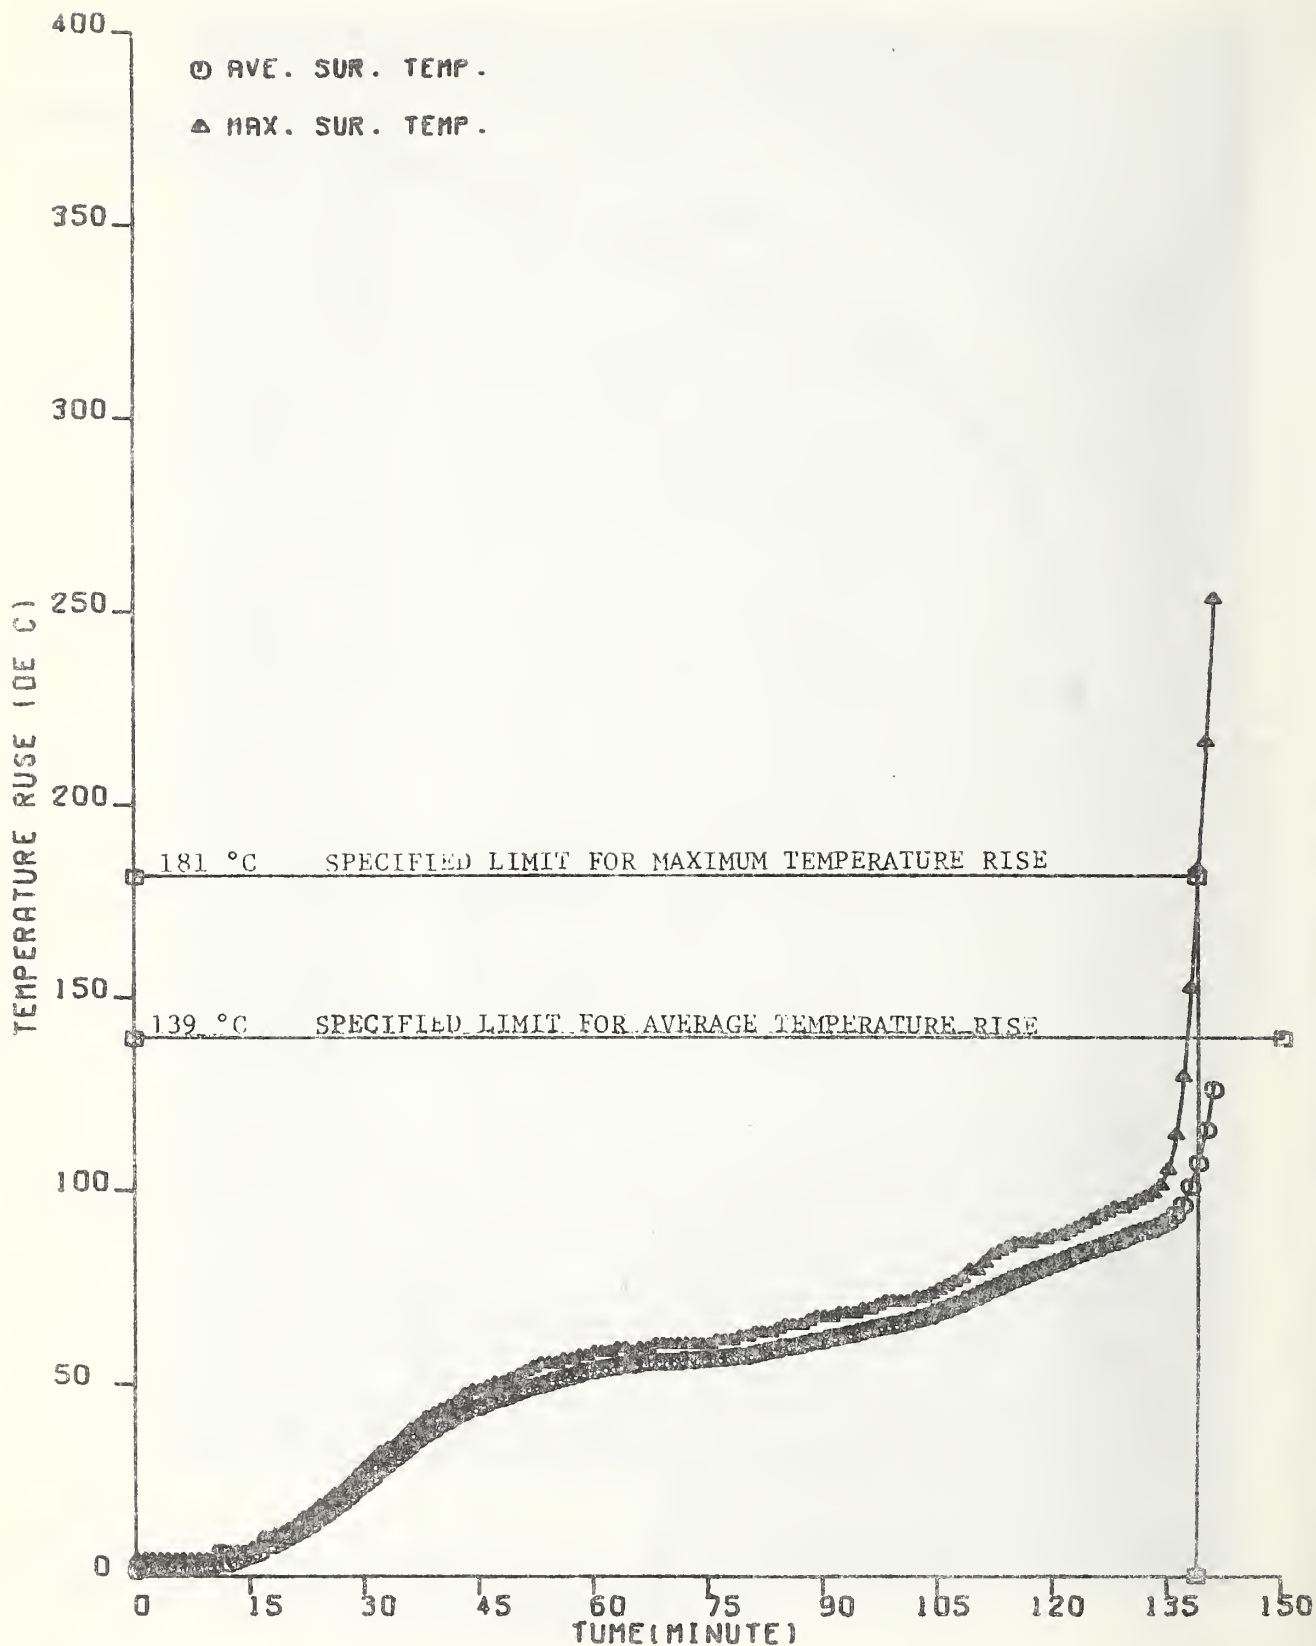
Figure 5.

The overall fire endurance of the assembly was 2 hr 19 min with failure by an excessive temperature rise (over 181°C) at a single point on the unexposed surface of the second (unexposed) wall of the north end panel.

MAX. AND AVE. TEMPERATURE RISE ON THE UNEXPOSED SURFACE TEST 504

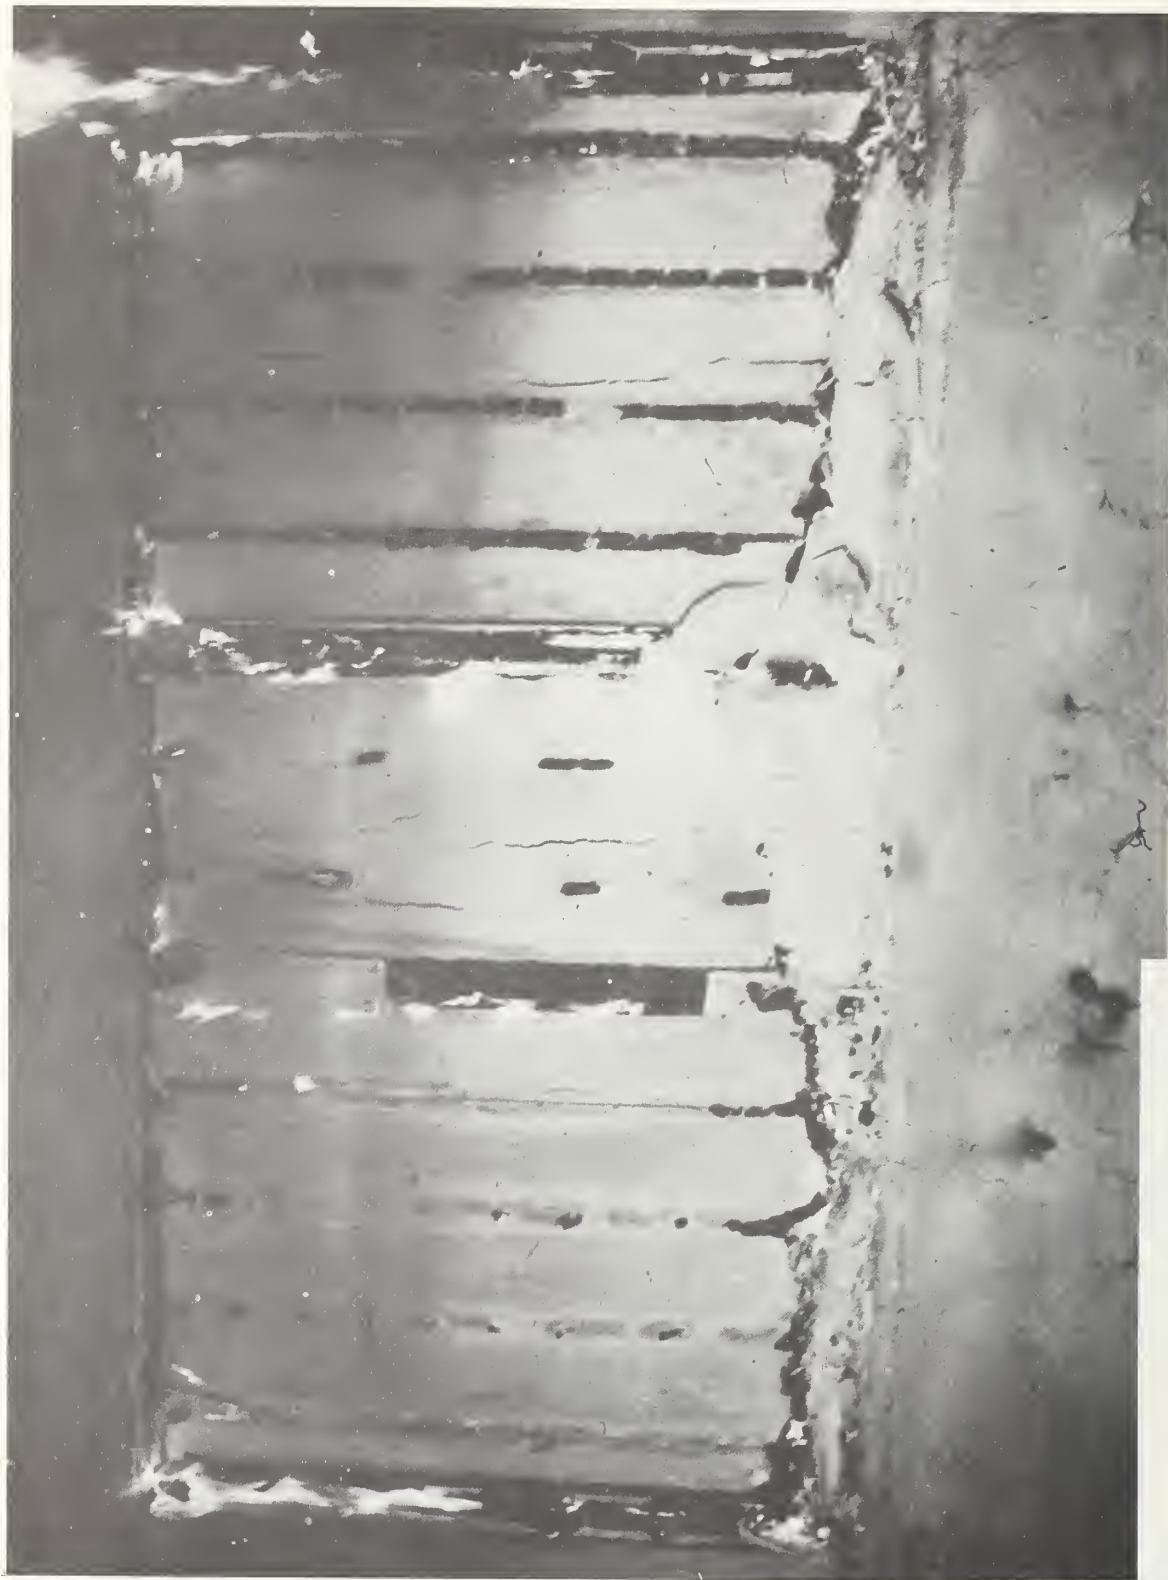
Figure 7 shows the exposed side of the assembly after it was removed from the furnace. All of the first wall has collapsed and most of the wood studs of the second wall have burned away. Note also long cracks on the gypsum boards.

Figure 7. The exposed side of the assembly after it was removed from the furnace.
